Sedimentation Survey of Lago El Guineo, Puerto Rico, October 2001

Water-Resources Investigations Report 03-4093

In cooperation with the
PUERTO RICO ELECTRIC POWER AUTHORITY

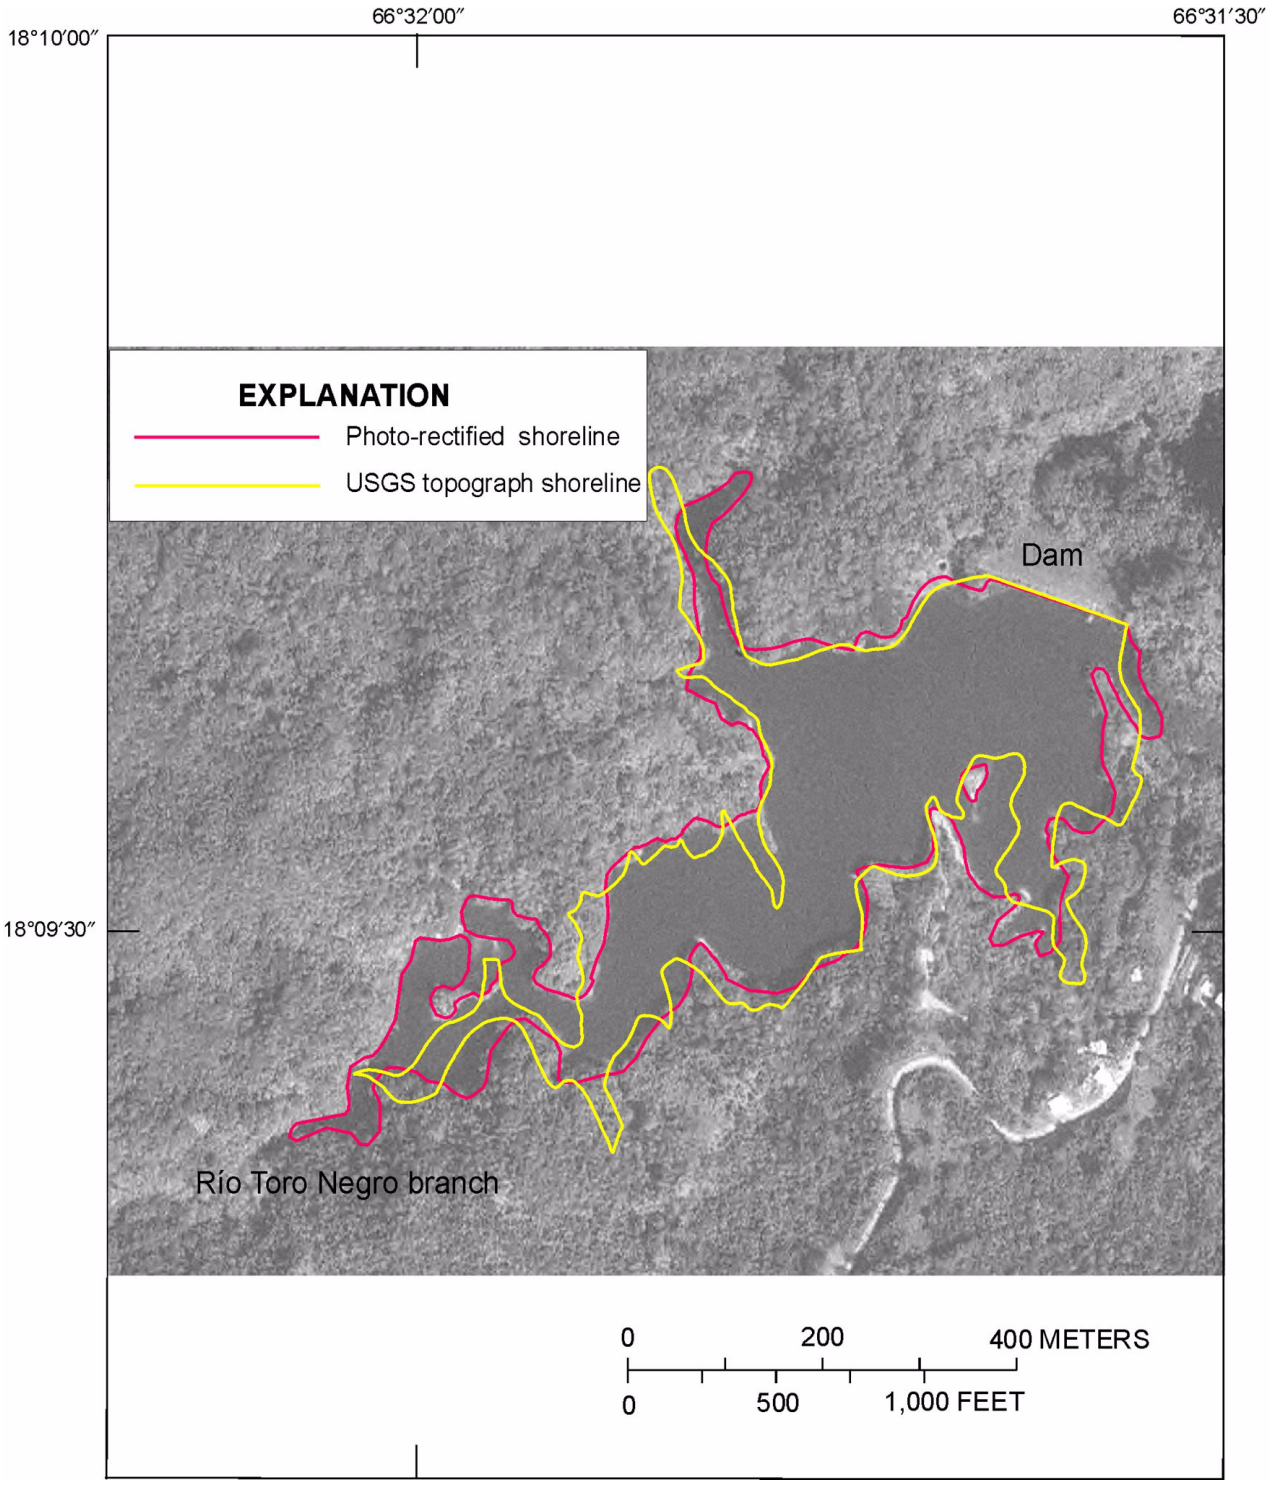
A digital map of the Lago El Guineo shoreline, extracted from the 1960 USGS Jayuya quadrangle, Puerto Rico, was loaded into a portable computer to serve as guideline for the reservoir navigation and field data collection. However, some inconsistencies were found between the field data and the GIS-generated shoreline map. The DGPS field data did not conform adequately with the shoreline extracted from the 1:20,000 USGS topographic map of Jayuya, Puerto Rico, suggesting that one of the two datasets was inaccurate. To verify if the field data were accurate, an aerial 1:5,000 digital orthophoto quadrangle (DOQ) of the reservoir shoreline was overlaid with the GIS topographic map shoreline and with the DGPS data. The DOQ and DGPS data matched appropriately (fig. 4). However, the topographic map did not match with the other two sets, indicating that the 1:20,000 map did not have the same accuracy as the DGPS and the DOQ data.

After eliminating the uncertainty of the field data, the Lago El Guineo shoreline was rectified using the DOQ and the DGPS data, which have a horizontal positional accuracy of less than 2 meters. The use of an inaccurate reservoir shoreline for contouring and volume calculations can yield substantial errors, particularly in a small reservoir like Lago El Guineo.

Figure 4. Comparison between the 1960 U.S. Geological Survey (USGS) Jayuya quadrangle shoreline, the 1:5,000 USGS digital orthophoto quadrangle data, and the photo-rectified shoreline of Lago El Guineo, Puerto Rico.

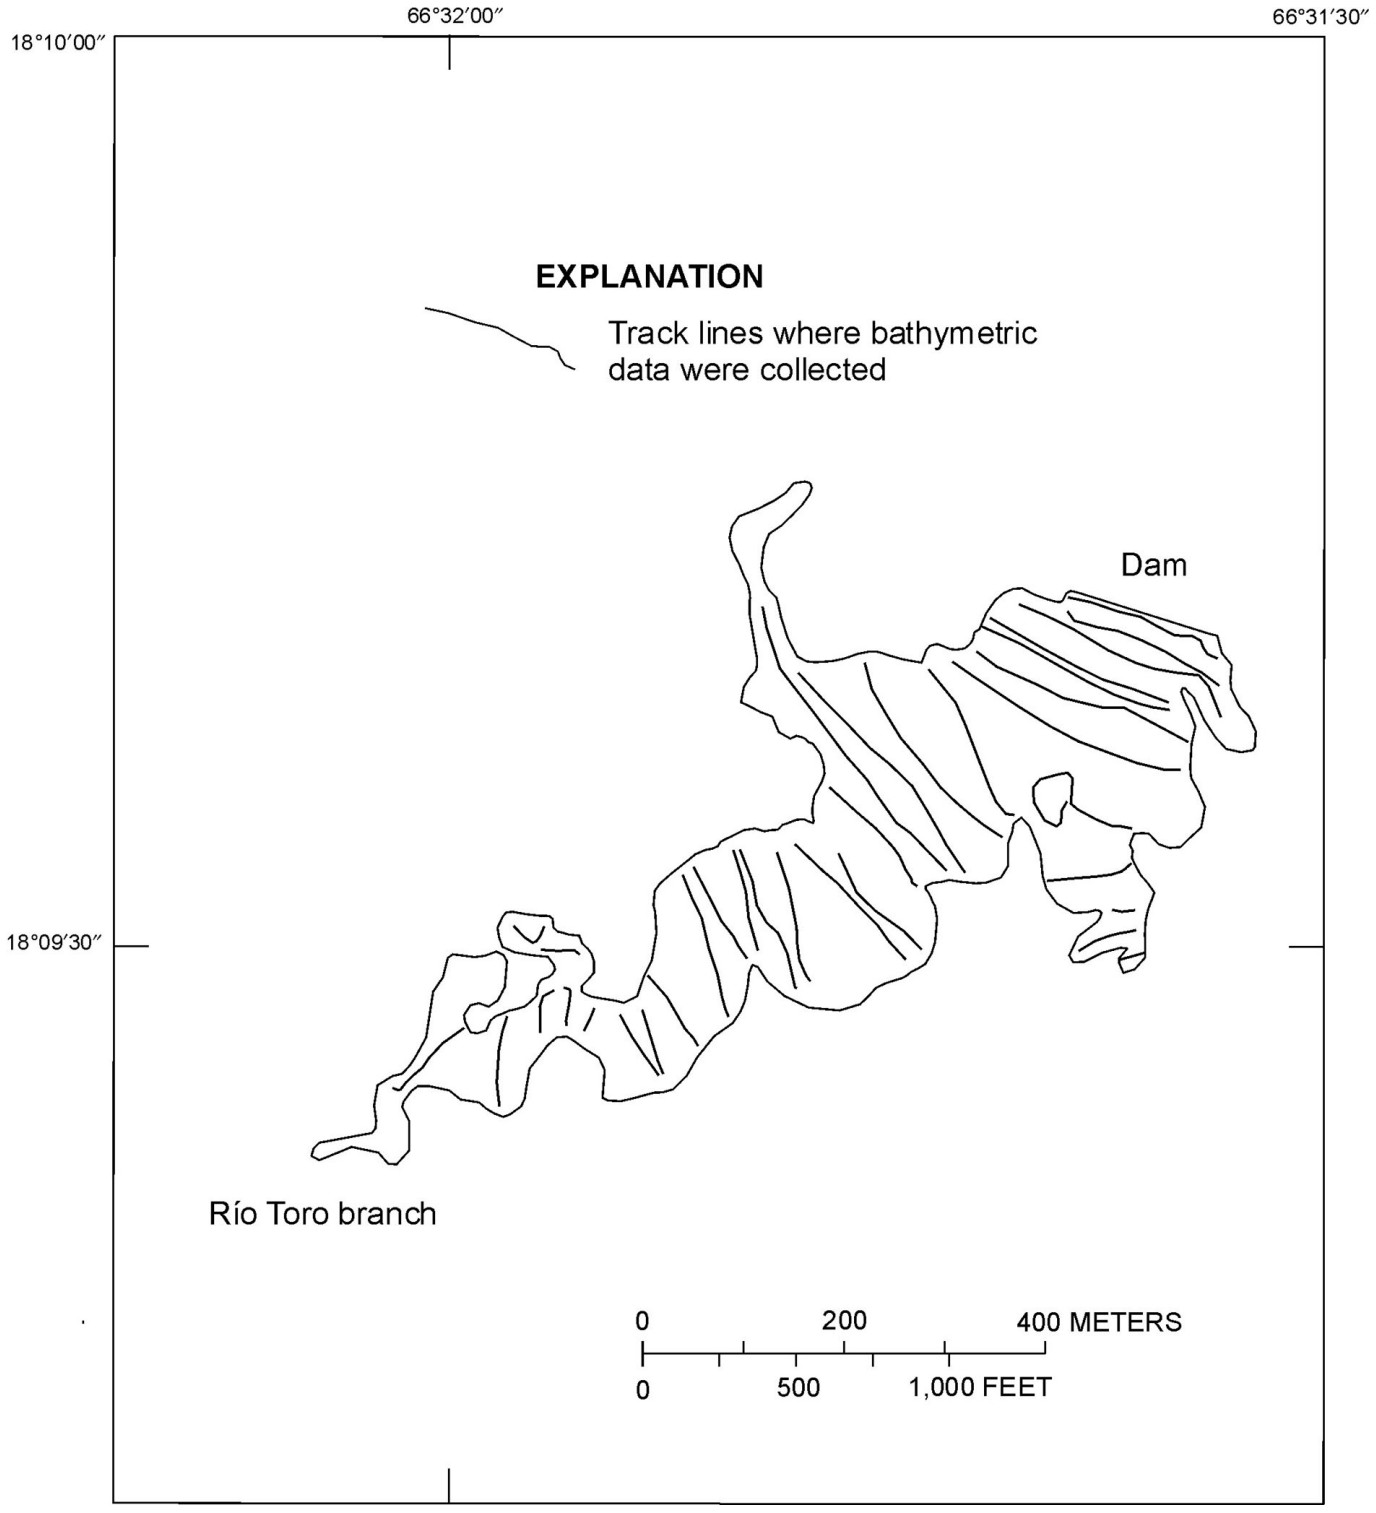
A total of 35 cross sections were planned using the GIS. However, vegetation growth inside the reservoir at a shallow area in the northern reach impeded navigation and limited data collection to 33 transects, for a total of 3,221 data points over the entire reservoir (fig. 5).

Figure 5. Actual track lines where bathymetric data were collected for the October 2001 sedimentation survey of Lago El Guineo, Puerto Rico. Shoreline from the 1:5,000 U.S. Geological Survey digital orthophoto quadrangle.

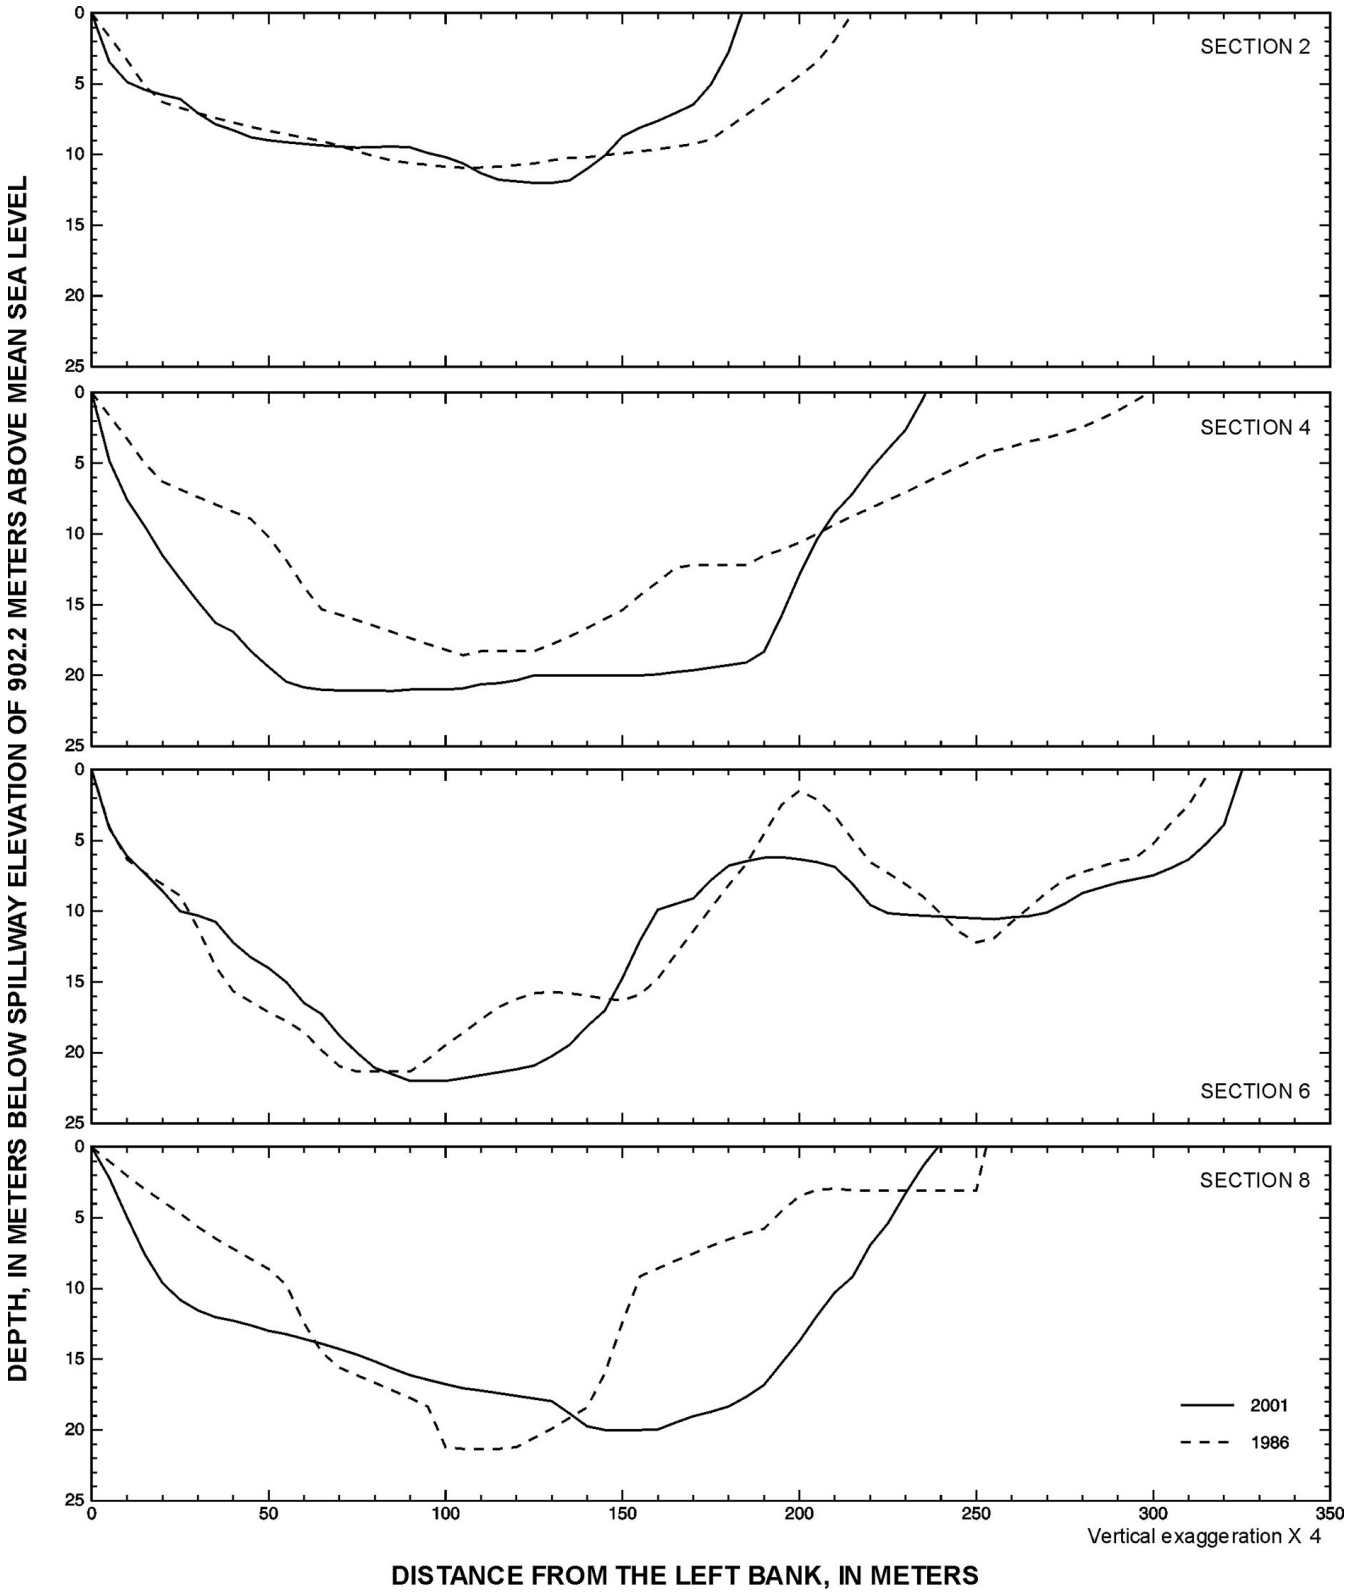
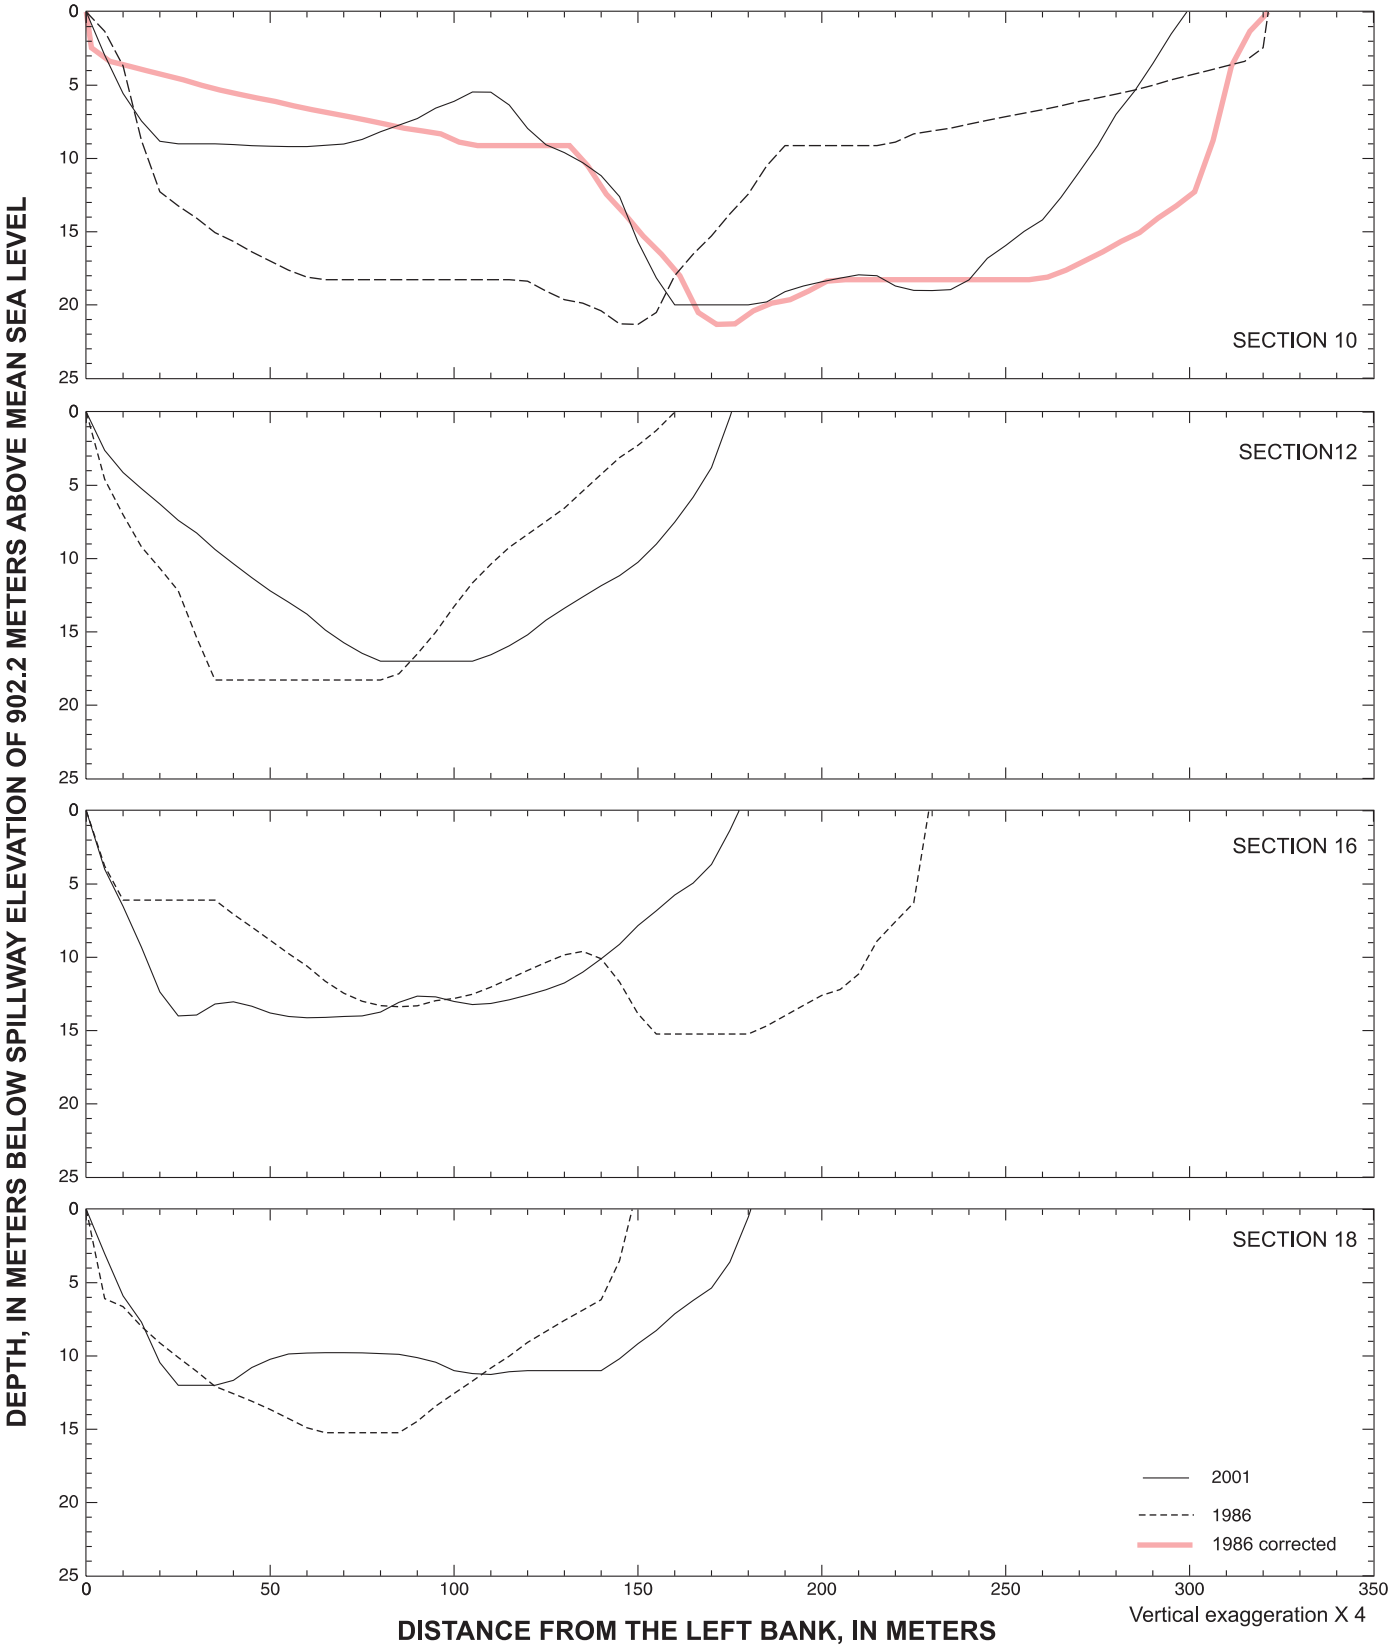
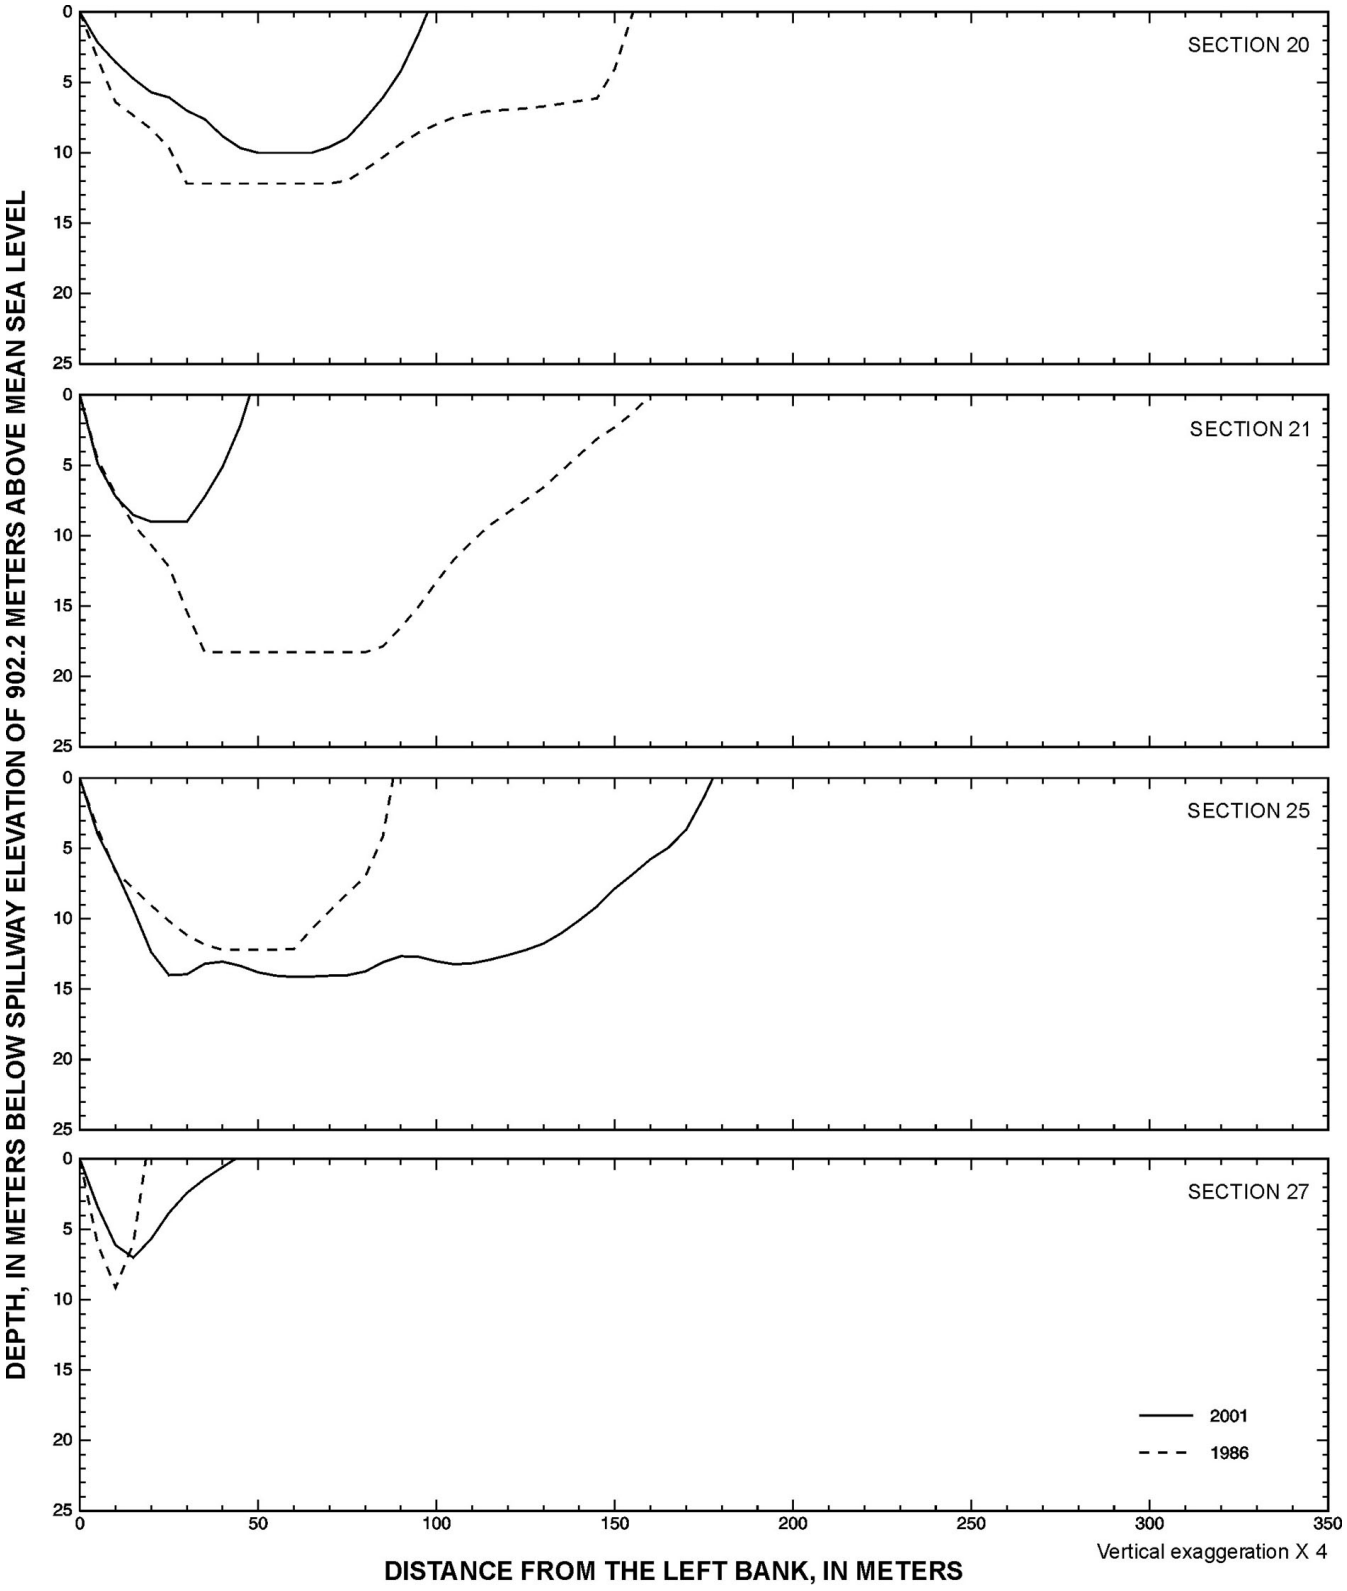
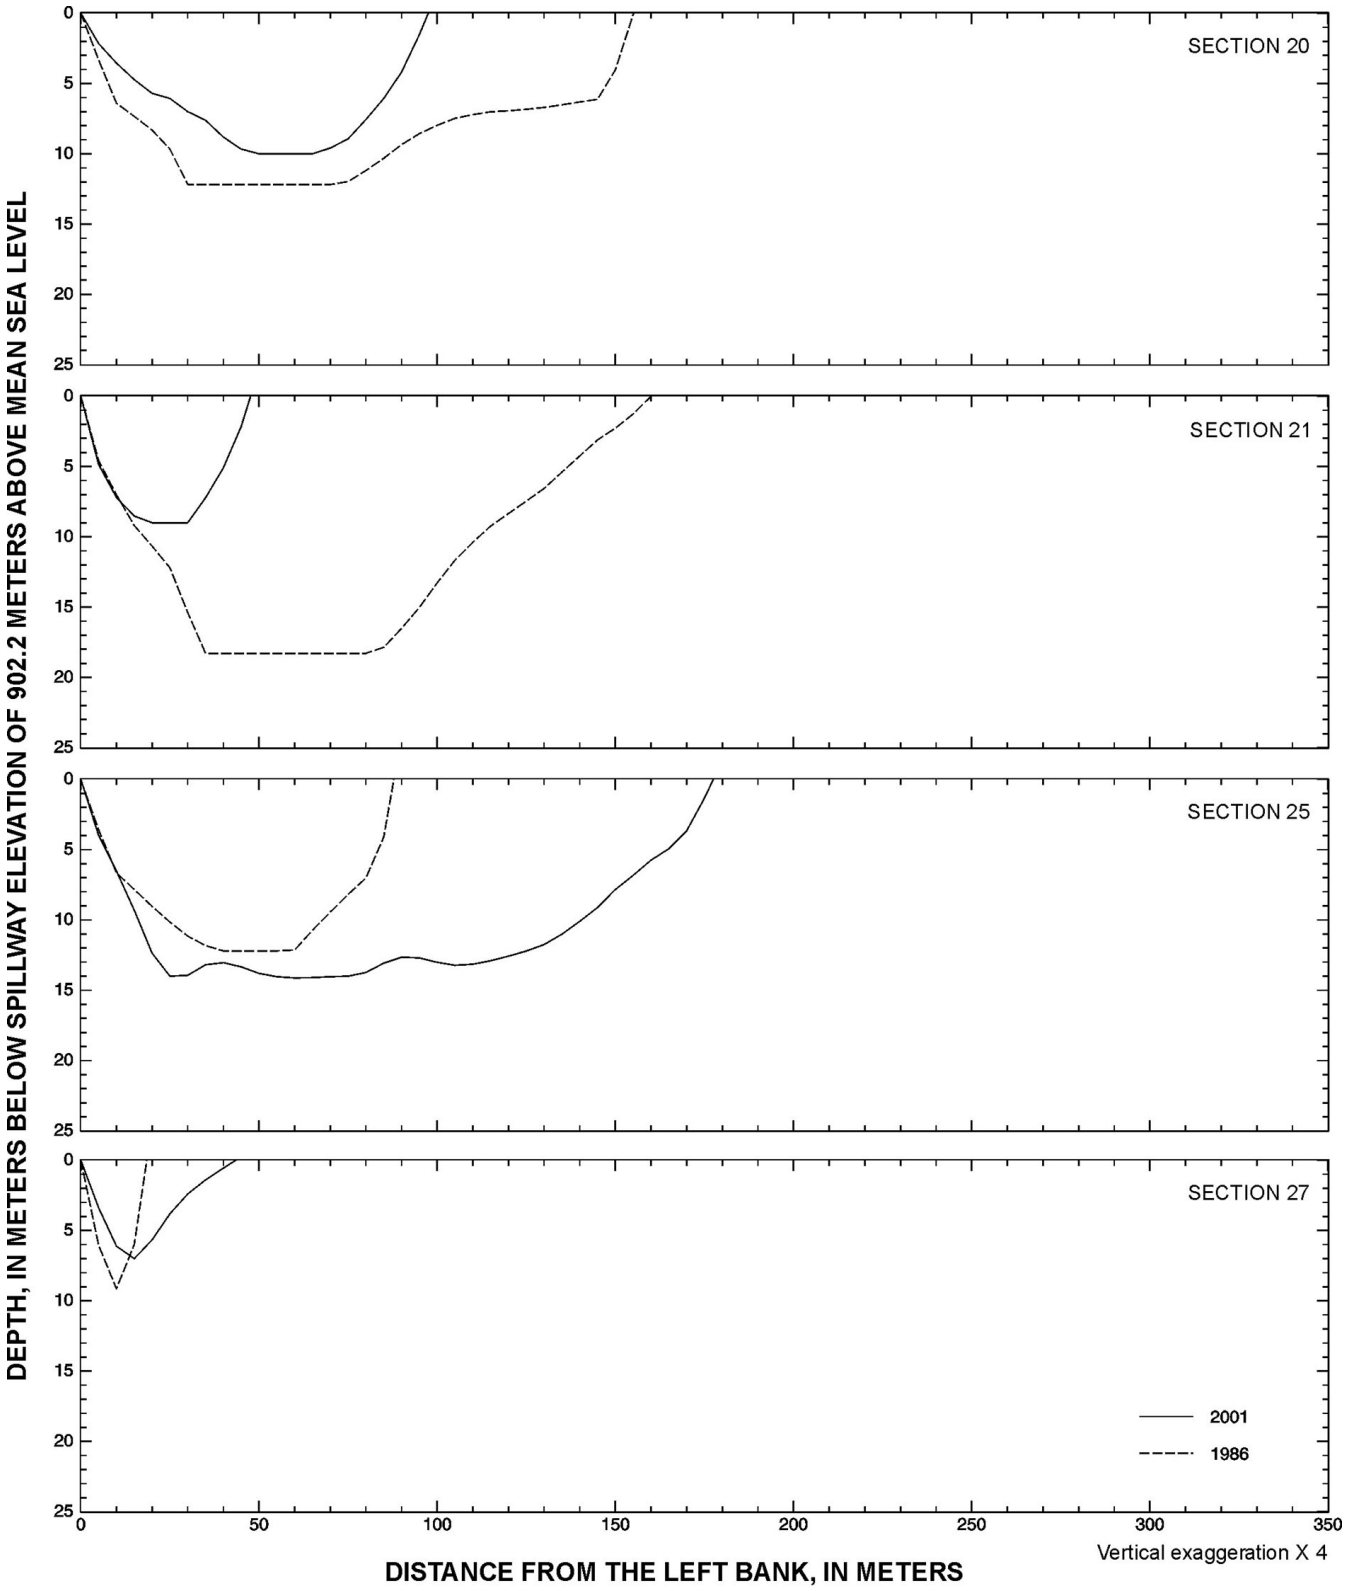
The storage capacity of Lago El Guineo as a function of pool elevation is listed at 1-meter intervals in table 3. The graphical relation between pool elevation and storage capacity is shown in figure 10. A comparison between the July 1986 and October 2001 selected cross sections to analyze sediment accumulation and distribution within the reservoir bottom is not adequate for most of the cross sections presented in figure 8, because of the difference between the two sets of shorelines and contour locations. For example, a comparison of cross section number 10 (fig. 8) shows what appears to be a different orientation in the plotting origin of the cross sections. However, if the 1986 cross section is mirror-imaged, the resulting cross section aligns fairly well with the 2001 DGPS-collected data and cross section. This misalignment may have happened when manually plotting the depth data in the 1986 bathymetric map (plate 2), since the difference is also noted when comparing plates 1 and 2. Although the 1986 shoreline and contours could be adjusted to fit the rectified October 2001 shoreline, it would create inconsistencies in the contour data, which would result in discrepancies. To properly adjust the 1986 dataset, the raw field data would be required, which are not available.

Figure 8. Selected cross sections generated from the triangulated irregular network (TIN) surface model of Lago El Guineo, Puerto Rico, for July 1986 and October 2001. Refer to figure 2 for cross-section locations.

Although these discrepancies impeded the comparison of these two cross-section datasets, the overall calculations of volume for the July 1986 survey are considered to be adequate because no anomalies are evident when comparing the historical sedimentation trends of Lago El Guineo (table 2). The increase in sedimentation rate and annual storage loss from 1986 to 2001 is probably the result of large sediment loads associated with Hurricanes Hortense and Georges in 1996 and 1998, respectively, as these storms severely impacted other upland reservoirs in Puerto Rico (Soler-López, 2000, 2001a).

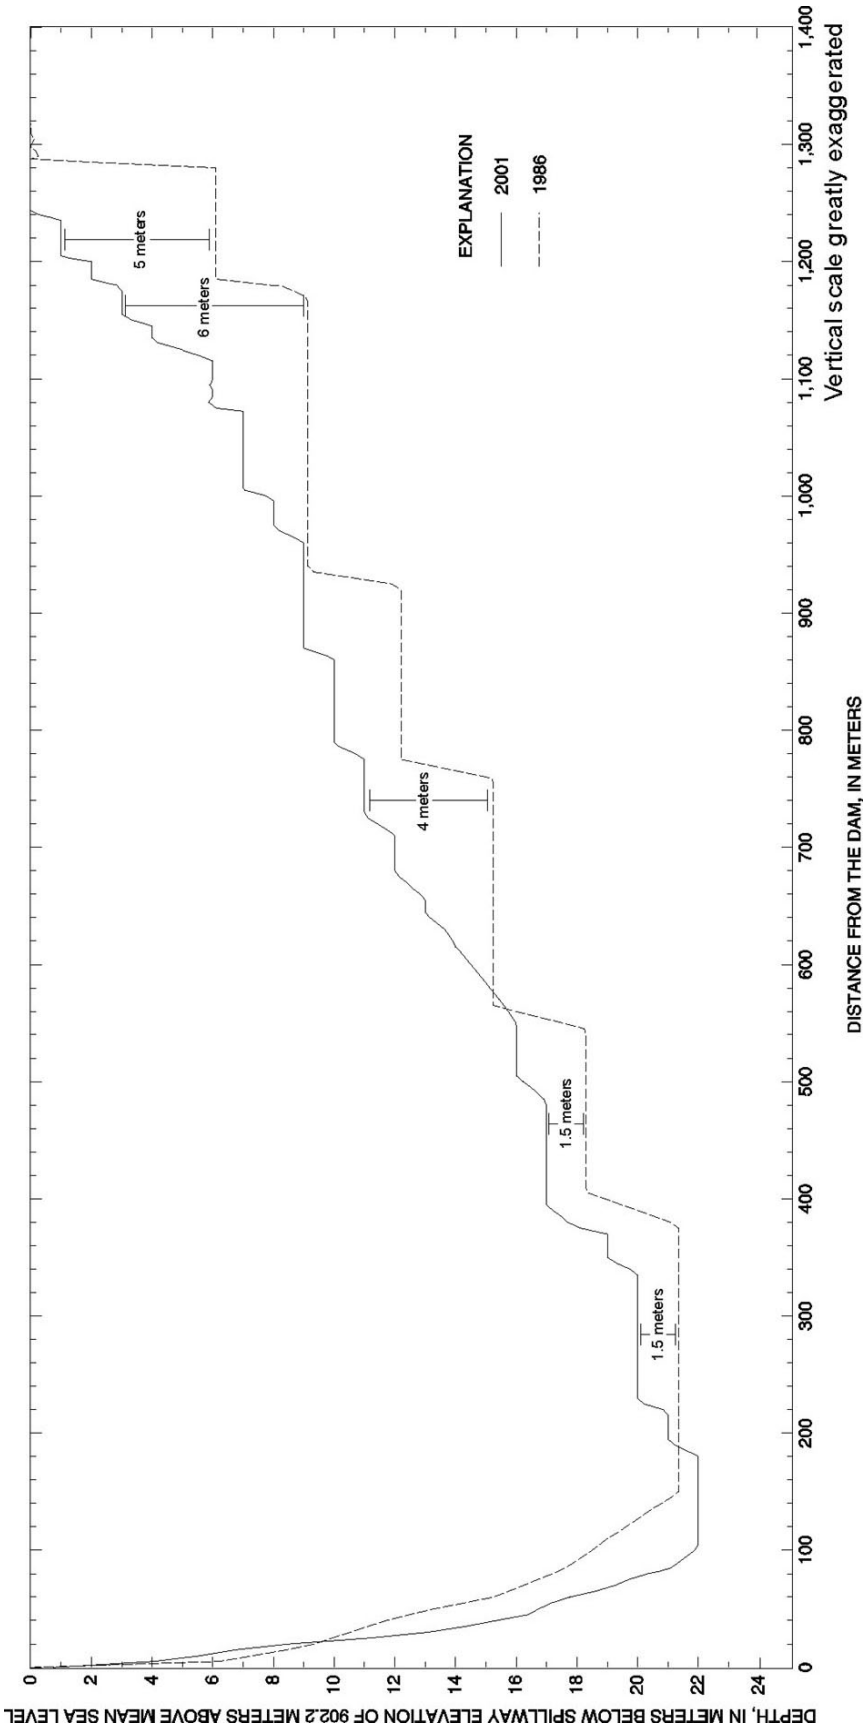
Figure 9. Longitudinal profiles along the thalweg of the Lago El Guineo, Puerto Rico, for July 1986 and October 2001.

The longitudinal profiles of Lago El Guineo for July 1986 and October 2001 are more appropriate than cross-section data for the analysis of the extent of sediment accumulation in the reservoir bottom because the profiles are more easily overlaid, and the discrepancies between the two sets of shorelines are negligible using the side-view perspective. From the profiles presented in figure 9, the rise on the reservoir bottom caused by sediment accumulation is evident. There are three distinct areas where sediment accumulation is substantial; approximately 750 meters, 1,050 meters, and 1,250 meters upstream from the dam. Although sediment accumulation is evident in practically all areas of the reservoir, the greater sediment accumulation has occurred in the upper reach, approximately 1,250 meters upstream from the dam, where the RíoToro Negro enters the reservoir (fig. 9). An average of about 5.5 meters in thickness of sediment has accumulated in this area, giving a sediment deposition rate of about 0.4 meter per year for the period of July 1986 to October 2001. Approximately 750 meters upstream from the dam, a thickness of 4 meters of sediment has accumulated, for a deposition rate of about 0.3 meter per year during the same period. From the dam to about 500 meters upstream, the material accumulation is less and more uniform; a layer about 1.5 meters thick has accumulated in the same period, resulting in a deposition rate of about 0.1 meter per year.

The power-generating intake structure is located in the deepest part of the reservoir, approximately 120 meters upstream from the dam and has a crown elevation of 876.30 meters above mean sea level. According to the 2001 survey data, the reservoir bottom has reached an elevation of 880.21 meters above mean sea level and although the intake tunnel is surrounded by a layer of sediment of about 4 meters thick, the structure is still operational. It is likely that the daily water releases for operation of the irrigation canal and power-generating process, along with the trashrack, maintain the intake clear of material deposition. This accumulation of material, however, has depleted the reservoir of the dead-storage volume used to accommodate sediment without disabling the intake structure. In addition, if water releases are discontinued for a prolonged period, the intake structure could be rendered inoperative. This situation has been noted in many of the reservoirs in Puerto Rico (Soler-López, 2001b).

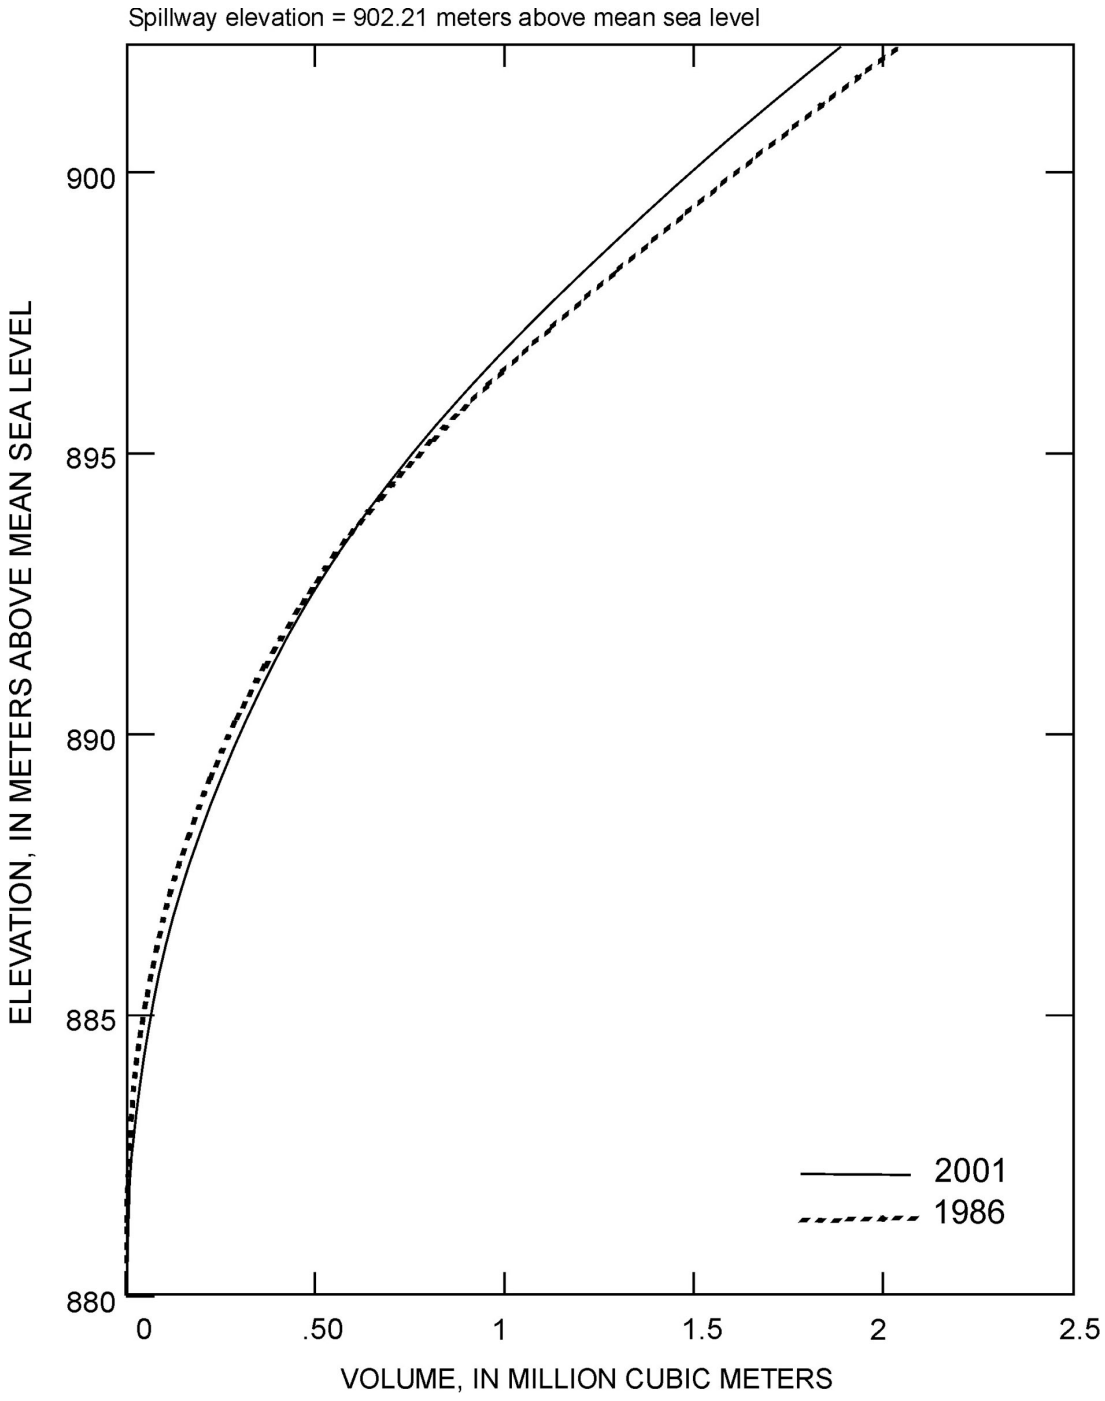
The storage capacity of Lago El Guineo has decreased from 2.29 million cubic meters in 1931 to 2.03 million cubic meters in July 1986, and to 1.89 million cubic meters in October 2001 (table 2). This represents a total storage loss of 260,000 cubic meters by July 1986 and 400,000 cubic meters by October 2001, or a loss of 11 and 17.5 percent, respectively. The average annual storage-capacity loss (equal to the sedimentation rate) of Lago El Guineo was 4,727 cubic meters for the period of 1931 to July 1986 (or 0.21 percent per year), increasing to 5,714 cubic meters for the period of 1931 to October 2001 (or 0.25 percent per year).

Figure 10. Relation between water-storage capacity and pool elevation of Lago El Guineo, Puerto Rico, for July 1986 and October 2001.
