INTRODUCTION

MAP SHOWING LANDSLIDES AND AREAS OF SUSCEPTIBILITY TO LANDSLIDING IN PUERTO RICO

By
Watson H. Monroe
1979

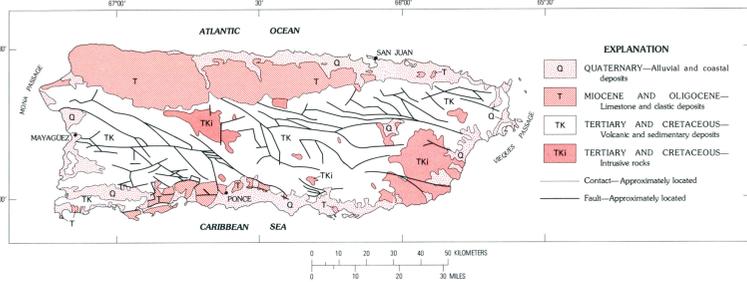
FIGURE 1—GENERALIZED GEOLOGIC MAP OF PUERTO RICO

Puerto Rico is a tropical island, elongate east-west and lying between the Caribbean Sea and the Atlantic Ocean. A central mountainous upland is composed of extensive and intrusive igneous rocks and minor amounts of limestone, sandstone, and conglomerate of Early Cretaceous to Eocene age. The upland separates belts of limestone of middle Tertiary age cropping out near the southern and northern coasts. Along the coasts, relatively narrow coastal plains (fig. 1) are made up of beaches, swamps, sand dunes, alluvial fans, and alluvial fans. These features consist of sand, gravel, and clay.

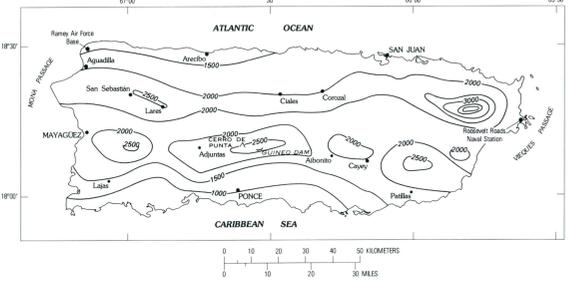
FIGURE 3—MAP SHOWING ANNUAL RAINFALL IN PUERTO RICO, CONTOURED IN MILLIMETERS. (Data from U.S. National Weather Service)

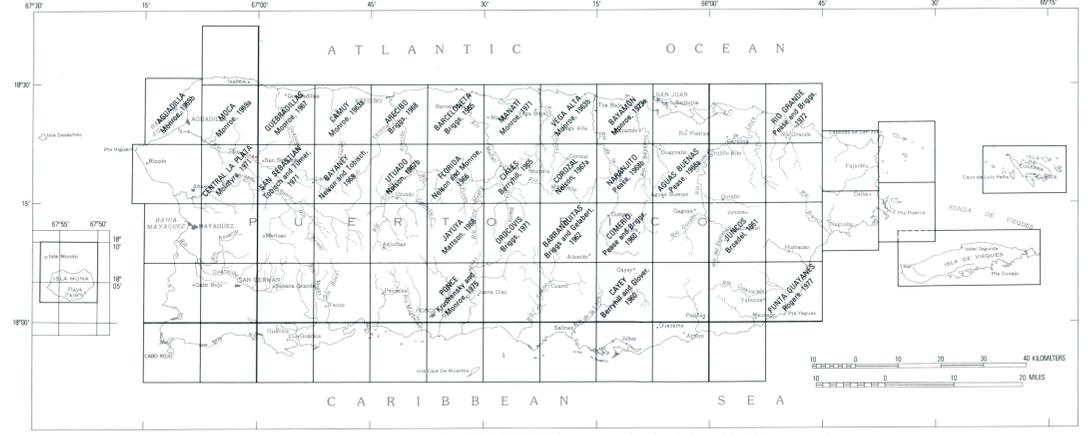
FIGURE 2—MAP OF PUERTO RICO SHOWING 7 1/2 MINUTE QUADRANGLES. (Geologic maps of quadrangles in which landslides are mapped, are referenced)
